Manhole Inspection Summary

Manhole # S43K__006MH

Insp Date: **6/3/08 11:05 AM**

Location Address: **across 1641 broadway st**

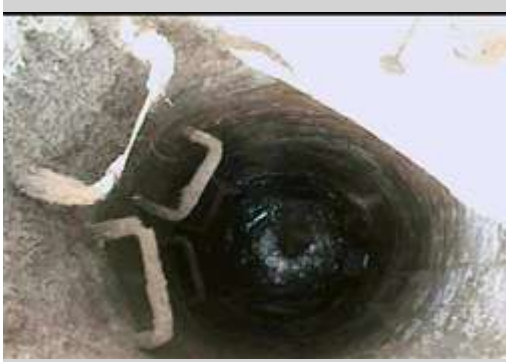
Defect 3

Count: **11** Missing: **2** ☒ **Corroded**

steps

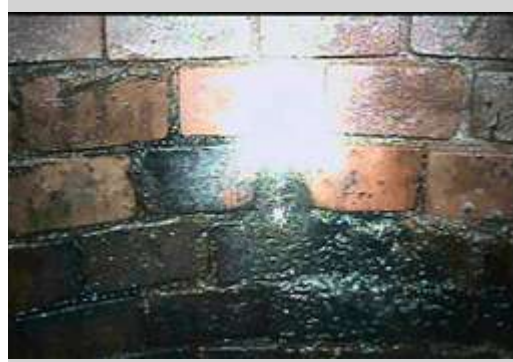
Defect 2

Infiltration: ☐ None ☐ Joint ☐ Cracks ☐ Mortar ☐ Roots ☒ **Wall**

BARREL_WALL

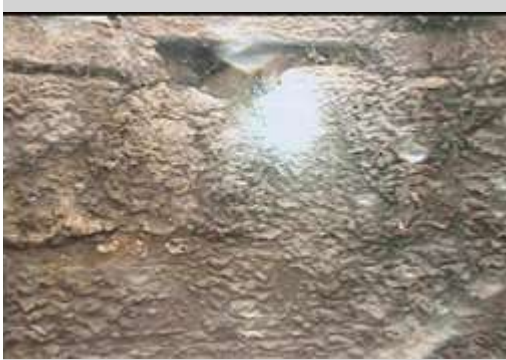
Defect 1

Condition: ☐ Sound ☐ Cracked ☐ Root Intrusion ☒ **Loose Brick** ☐ Deteriorated

CHIMNEY_COND_LOOSE_BRICKS and
CHIMNEY_COND_PARGED

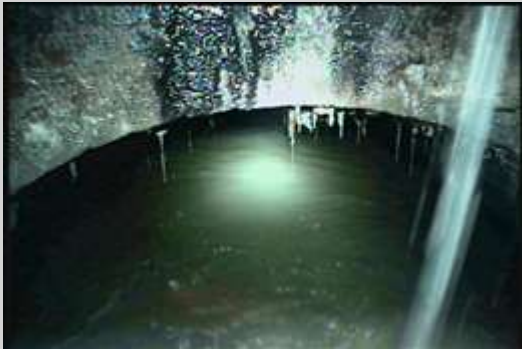
12 O'Clock Outflow

42 in. Circular Gravity Sewer
Pipe Out @ 12 O'Clock

Pipe Material: **Clay** ☐ Pipe Lined

Invert Depth: 19.19 (ft.) Flow Characteristics: **Fast**

Deposits: ☒ None ☐ Mud ☐ Sludge ☐ Debris ☐ Grease

Infiltration: **None** Pipe Seal Cond: **Unknown**

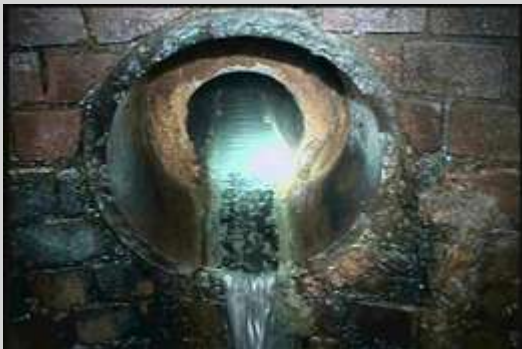
3 O'Clock Inflow

8 in. Circular Gravity Sewer
Pipe In @ 3 O'Clock

Pipe Material: **Clay** ☐ Pipe Lined

Invert Depth: 12.20 (ft.) Flow Characteristics: **Fast**

Deposits: ☒ None ☐ Mud ☐ Sludge ☐ Debris ☐ Grease

Infiltration: **None** Pipe Seal Cond: **Unknown**

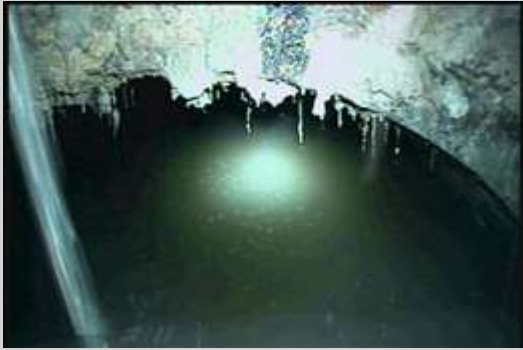
6 O'Clock Inflow

42 in. Circular Gravity Sewer
Pipe In @ 6 O'Clock

Pipe Material: **Clay** ☐ Pipe Lined

Invert Depth: 19.13 (ft.) Flow Characteristics: **Fast**

Deposits: ☒ None ☐ Mud ☐ Sludge ☐ Debris ☐ Grease

Infiltration: **None** Pipe Seal Cond: **Unknown**

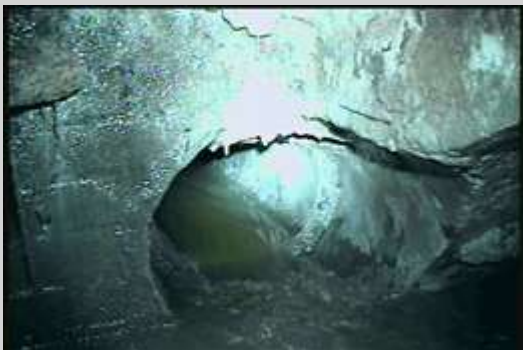
9 O'Clock Inflow

12 in. Circular Gravity Sewer
Pipe In @ 9 O'Clock

Pipe Material: **Clay** ☐ Pipe Lined

Invert Depth: 19.10 (ft.) Flow Characteristics: **Fast**

Deposits: ☒ None ☐ Mud ☐ Sludge ☐ Debris ☐ Grease

Infiltration: **None** Pipe Seal Cond: **Unknown**
